Uniform Property Data Report (UPDR)

Example: Single-Family Detached Property (SF1)

SINGLE FAMILY
1023 MAIN ST, ANYWHERE, AB 99999
<https://URL>

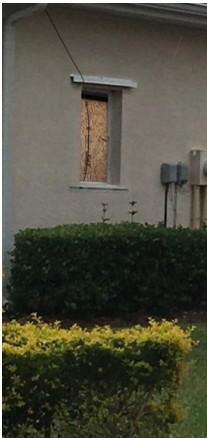
Exterior - Defect - Missing Window

Apparent Defects, Damages, Deficiencies (Exterior - Dwelling)			
Feature	Deficiency	Detail and Description Description	Severe Deficiency?
Windows	Damage	Missing window; A window is missing potentially letting in water and causing additional damage.	Yes

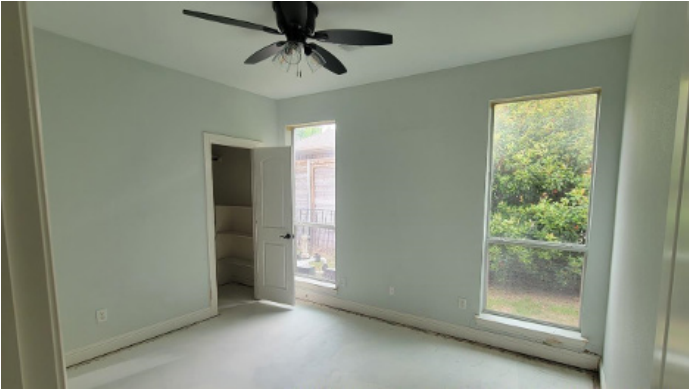
Unit Interior - Defect - Missing Flooring

Feature	Deficiency	Detail and Description	Severe Deficiency?
Flooring	Missing	Other; Missing flooring in bedroom and closet.	No
	Missing	Other; Missing flooring in bedroom.	No

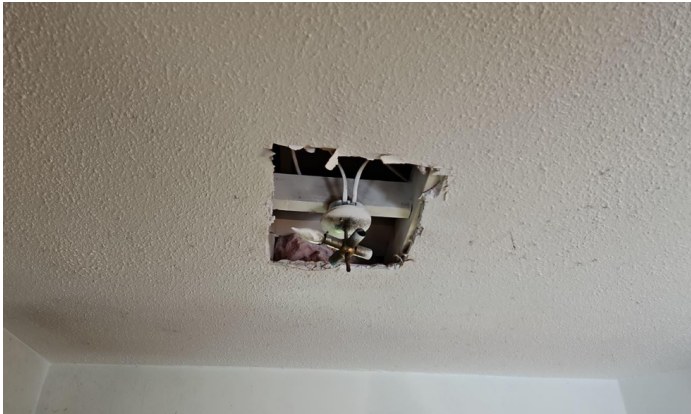
Vehicle Storage - Defect - Hole in Ceiling

Apparent Defects, Damages, Deficiencies (Vehicle Storage)			
Feature	Deficiency	Detail and Description	Severe Deficiency?
Ceiling	Other	Other; Light fixture missing. Hole in ceiling.	No
