Uniform Property Data Report (UPDR)

Example: Single-Family Detached Property (SF1)

SINGLE FAMILY
1023 MAIN ST, ANYWHERE, AB 99999
[https://URL](#)

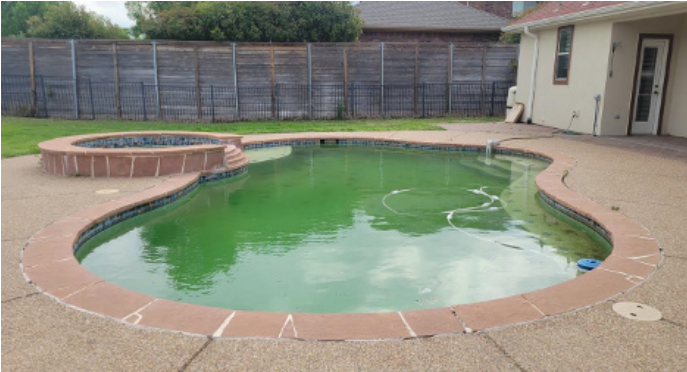
Site Improvements - Inground Pool

Pool Concern(s)	Comment
Inground Pool; Unsanitary Water	Ingound pool is uncovered with unsanitary water.

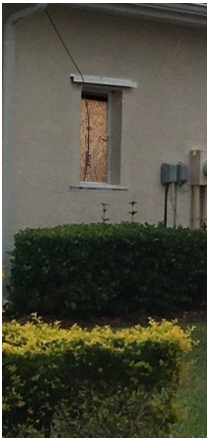
Exterior - Defect - Missing Window

Apparent Defects, Damages, Deficiencies (Exterior - Dwelling)				
Feature	Deficiency	Detail and Description	Description	Severe Deficiency?
Windows	Damage	Missing window; A window is missing potentially letting in water and causing additional damage.		Yes

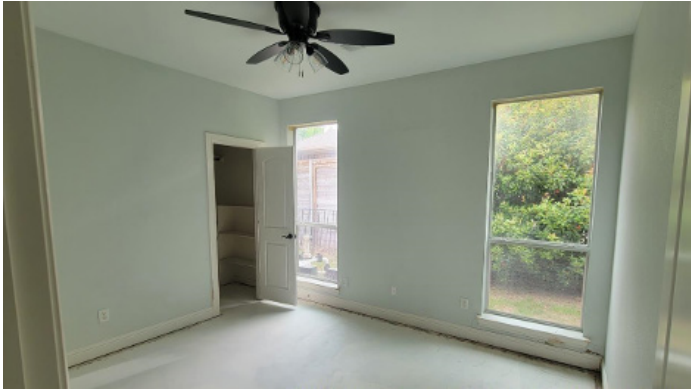
Unit Interior - Defect - Missing Flooring

Feature	Deficiency	Detail and Description	Severe Deficiency?
Flooring	Missing	Other; Missing flooring in bedroom and closet.	No
	Missing	Other; Missing flooring in bedroom.	No

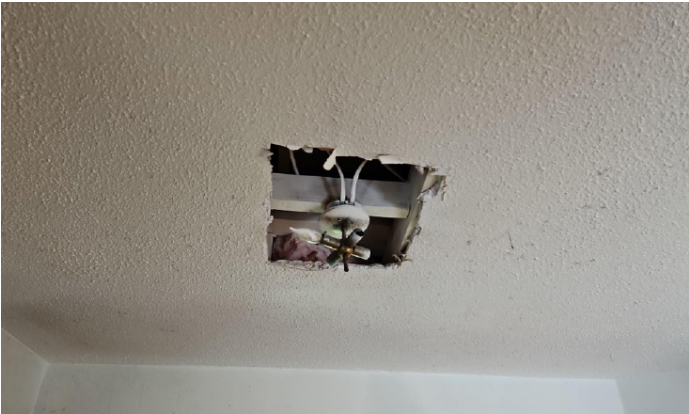
Vehicle Storage - Defect - Hole in Ceiling

Feature	Deficiency	Detail and Description	Severe Deficiency?
Ceiling	Other	Other; Light fixture missing. Hole in ceiling.	No
