Property Quality Ratings Reference Guide

January 2021

The Noble Appraiser Series
**The Quality Rating
Trees of Turmoil**

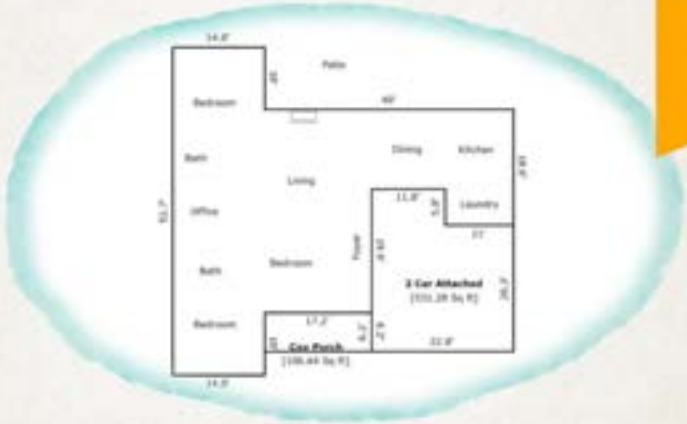
Q3

but it was built from readily available designer plans...

The floor plan shows a house with a 3-car attached garage (100.28 sq ft) and a car porch (100.44 sq ft). Other rooms include a living area, dining room, kitchen, and multiple bedrooms and bathrooms. Dimensions are provided for various sections of the house.

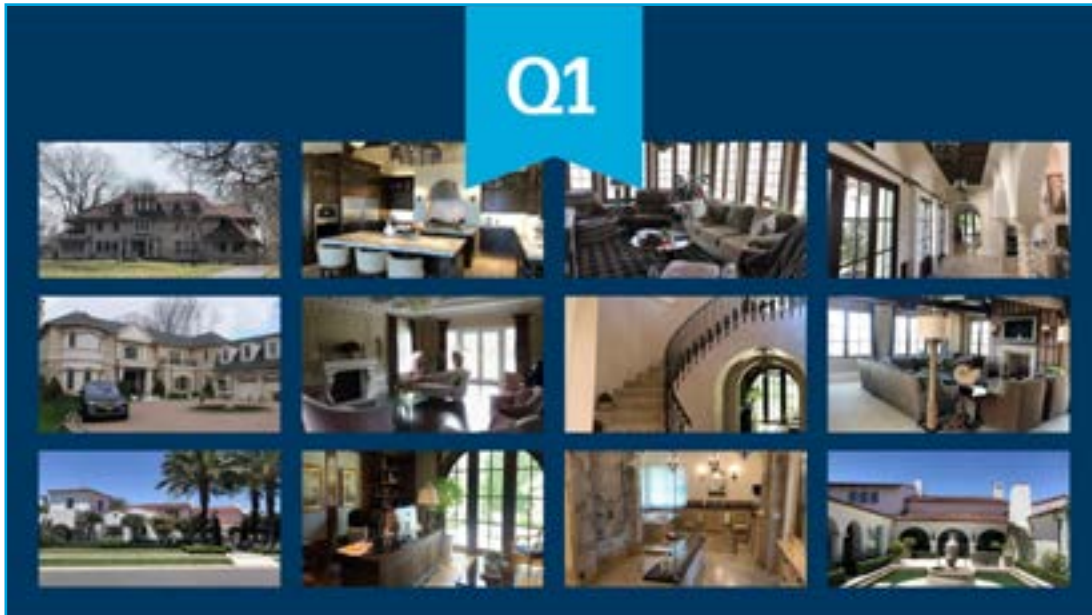
Q1

Dwellings with this quality rating are usually unique structures that are individually designed by an architect for a specified user. Such residences typically are constructed from detailed architectural plans and specifications and feature an exceptionally high level of workmanship and exceptionally high grade materials throughout the interior and exterior of the structure. The design features exceptionally high-quality exterior refinements and ornamentation, and exceptionally high-quality interior refinements. The workmanship, materials, and finishes throughout the dwelling are of exceptionally high quality.

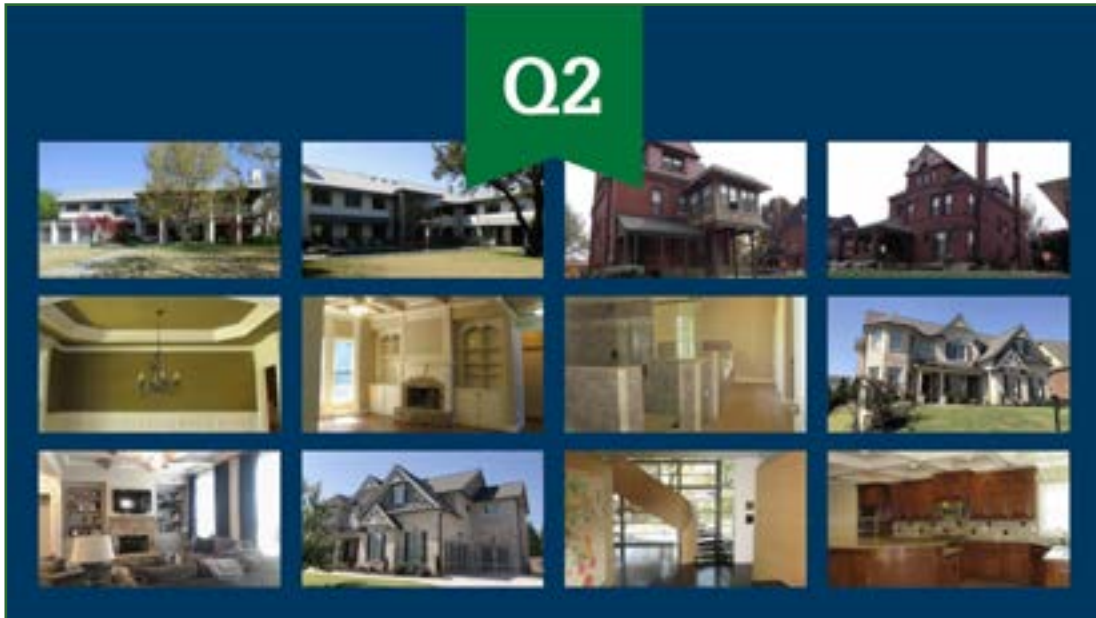
Q2

Dwellings with this quality rating are often custom designed for construction on an individual property owner's site. However, dwellings in this quality grade are also found in high-quality tract developments featuring residences constructed from individual plans or from highly modified or upgraded plans. The design features detailed, high-quality exterior ornamentation, high-quality interior refinements, and detail. The workmanship, materials, and finishes throughout the dwelling are generally of high or very high quality.

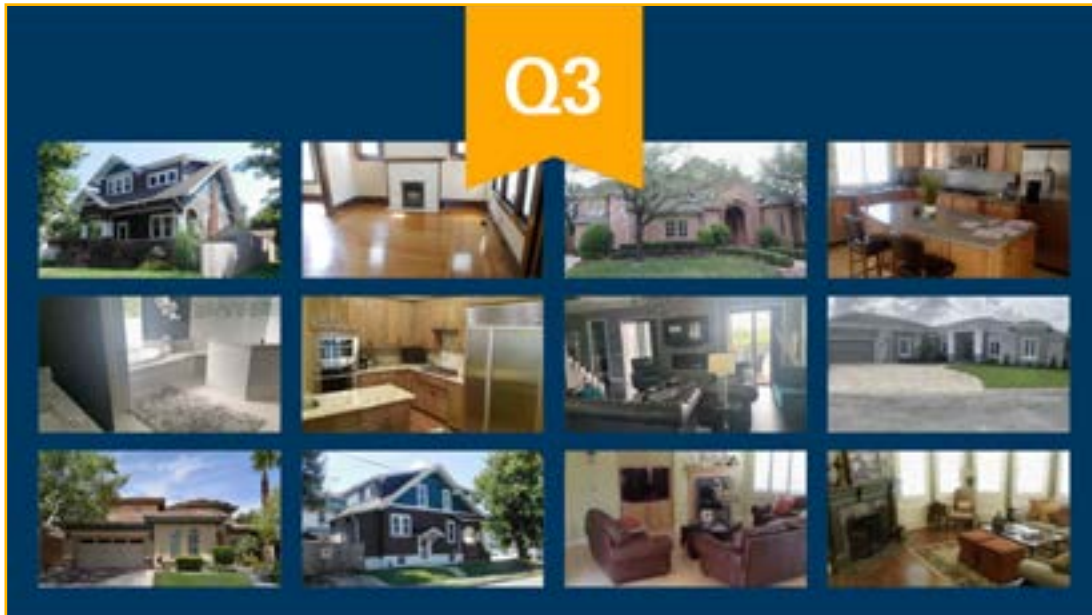
Q3

Dwellings with this quality rating are residences of higher quality built from individual or readily available designer plans in above-standard residential tract developments or on an individual property owner's site. The design includes significant exterior ornamentation and interiors that are well finished. The workmanship exceeds acceptable standards, and many materials and finishes throughout the dwelling have been upgraded from "stock" standards.

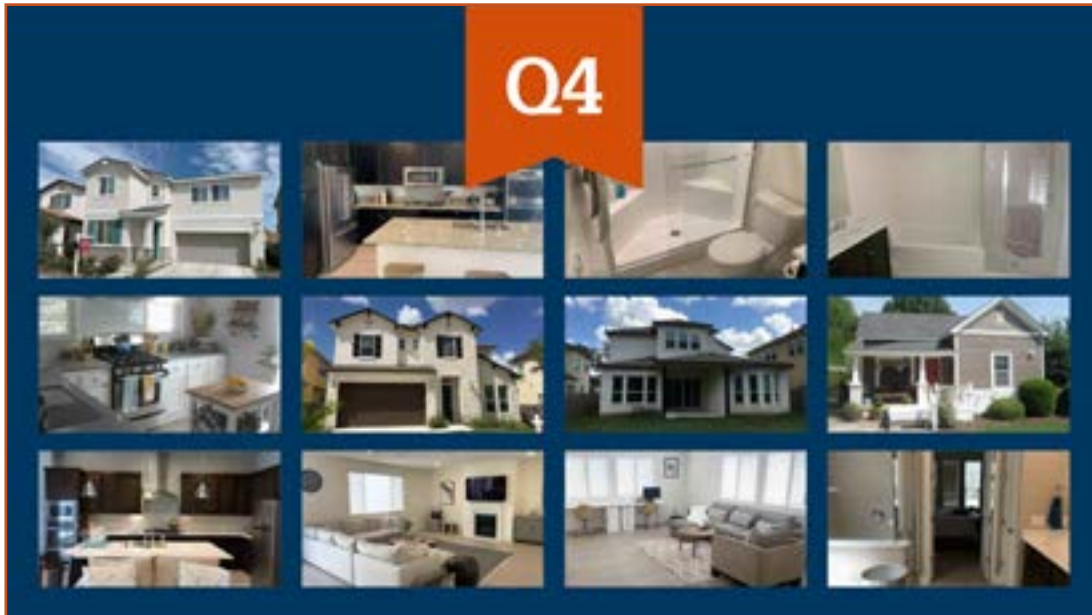
Q4

Dwellings with this quality rating meet or exceed the requirements of applicable building codes. Standard or modified standard building plans are utilized, and the design includes adequate fenestration and some exterior ornamentation and interior refinements. Materials, workmanship, finish, and equipment are of stock or builder grade and may feature some upgrades.

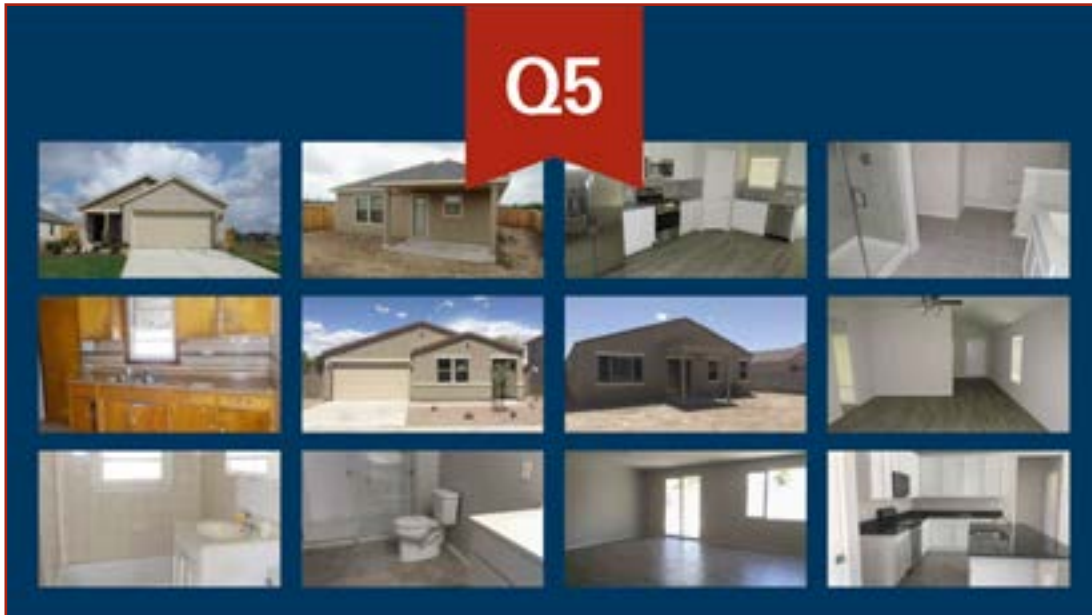
Q5

Dwellings with this quality rating feature economy of construction and basic functionality as main considerations. Such dwellings feature a plain design using readily available or basic floor plans featuring minimal fenestration and basic finishes with minimal exterior ornamentation and limited interior detail. These dwellings meet minimum building codes and are constructed with inexpensive, stock materials with limited refinements and upgrades.

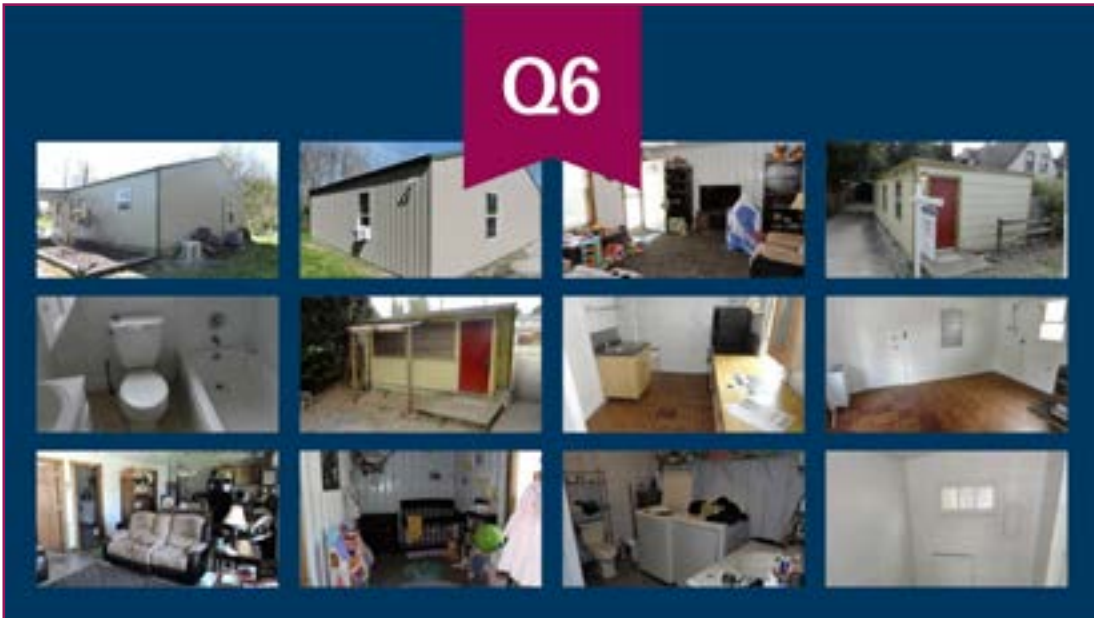
Q6

Dwellings with this quality rating are of basic quality and lower cost; some may not be suitable for year-round occupancy. Such dwellings are often built with simple plans or without plans, often utilizing the lowest quality building materials. Such dwellings are often built or expanded by persons who are professionally unskilled or possess only minimal construction skills. Electrical, plumbing, and other mechanical systems and equipment may be minimal or nonexistent. Older dwellings may feature one or more substandard or nonconforming additions to the original structure.
