# Uniform Appraisal Dataset (UAD) Specification

## **Appendix D-1: Condominium Scenario (Condo1)**

# Uniform Residential Appraisal Report

201 UNDERHILL DR, UNIT 202, NOWHERE, CA 90021

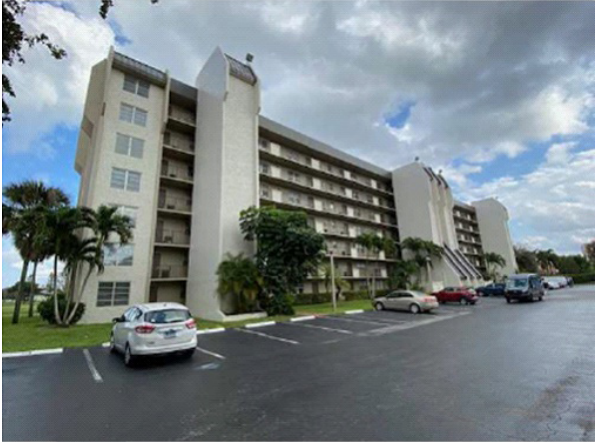
Dwelling Rear

The structure’s overall condition is adequately maintained, with several areas that have been updated. There were no noticeable areas of defects within the structure that required repairs at the time of inspection.

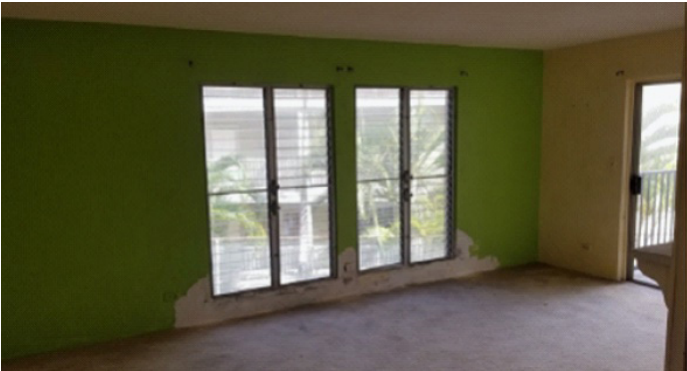
Apparent Defects, Damages, Deficiencies - Walls and Ceiling - Peeling Paint

Feature	Location	Description	Affects Soundness or Structural Integrity	Recommended Action
Walls and Ceiling	Bedroom	Peeling paint was observed in one of the bedrooms of unit. Appears to be typical deferred maintenance.	No	None
