Uniform Appraisal Dataset (UAD) Specification

Appendix D-1: Condominium Scenario (Condo1)

Uniform Residential Appraisal Report

201 UNDERHILL DR, UNIT 202, NOWHERE, CA 90021

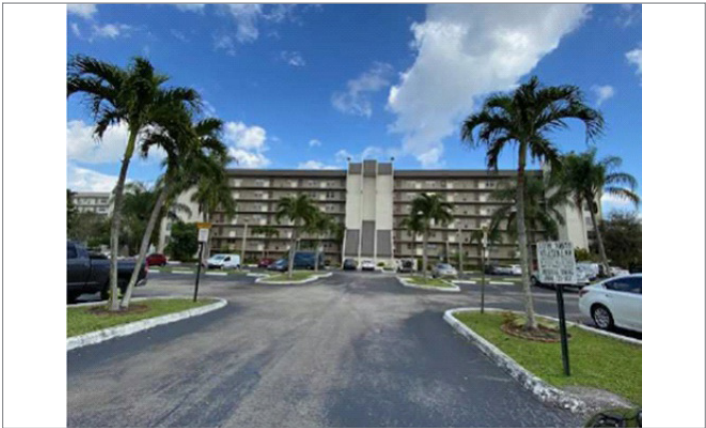
Subject Property Units in	
Structure	1
Structure Design	Mid-rise
Floors in Building	8
Front Door Elevation	8-9 Ft.
Year Built	~1973
Converted Area	None

The structure’s overall condition is adequately maintained, with several areas that have been updated. There were no noticeable areas of defects within the structure that required repairs at the time of inspection.

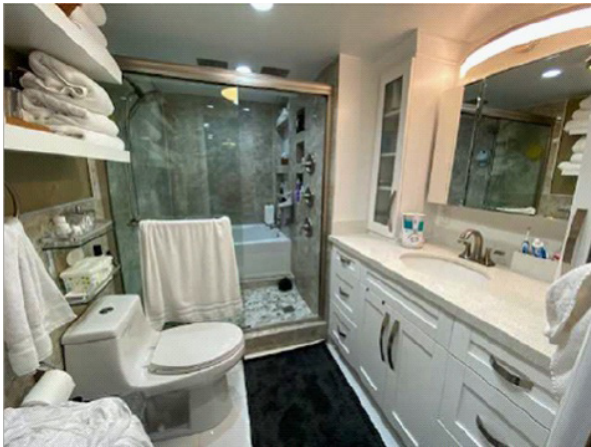
Level 1 - Bath - Full - Bath 2

Room	Update Status	Time Frame	Quality Comment	Condition Status	Condition Comment
Kitchen Level 1	Fully Updated	1-5 years	GE Monogram appliances and hardwood painted cabinets.	New or Like New	Add comment if needed.
Bath - Full Level 1	Fully Updated	1-5 years	Tile shower and custom vanity, owners utilized custom designer for tile work.	Typical Wear and Tear	Add comment if needed.
Bath - Full Level 1	Fully Updated	1-5 years	Tile shower and custom vanity.	New or Like New	Bathroom rarely used, shows nicely.

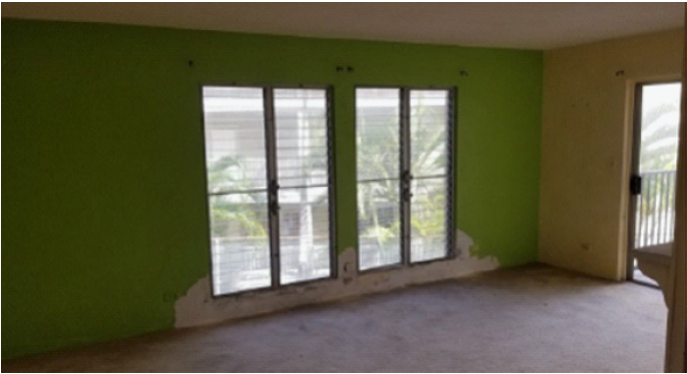
Apparent Defects, Damages, Deficiencies - Walls and Ceiling - Peeling Paint

Feature	Location	Description	Affects Soundness or Structural Integrity	Recommended Action
Walls and Ceiling	Bedroom	Peeling paint was observed in one of the bedrooms of unit. Appears to be typical deferred maintenance.	No	None

Feature	Location	Description	Affects Soundness or Structural Integrity	Recommended Action
Unit Interior				
Walls and Ceiling	Bedroom	Peeling paint was observed in one of the bedrooms of unit. Appears to be typical deferred maintenance.	No	None
Subject Property Amenities				
Balcony	Adjacent to Living Room	Balcony is functional, but shows overall age and some deferred maintenance, mainly from the cracking of concrete. The condo association has systematically been moving throughout the building and making repairs as needed throughout all unit balconies.	No	None

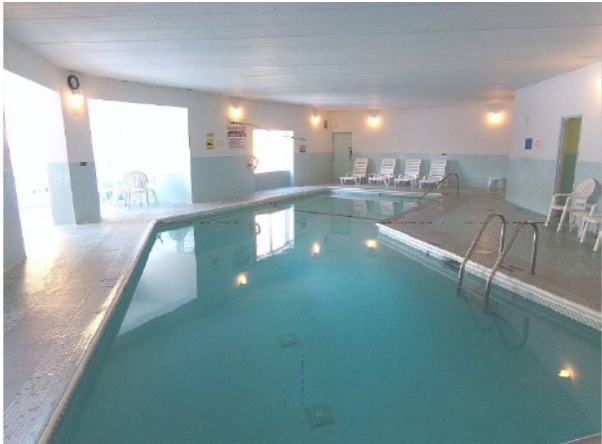
Common Amenity or Service - Indoor Pool

The common elements appear to be adequately maintained. Within this project you have access to parking spaces adequate for the size of the community and have access to a common pool and spa area.
