Uniform Appraisal Dataset (UAD) Specification

Appendix D-1: Manufactured Home Scenario 1 (MH1)

Uniform Residential Appraisal Report

123 ANYWHERE ST, SOME CITY, VA 20141

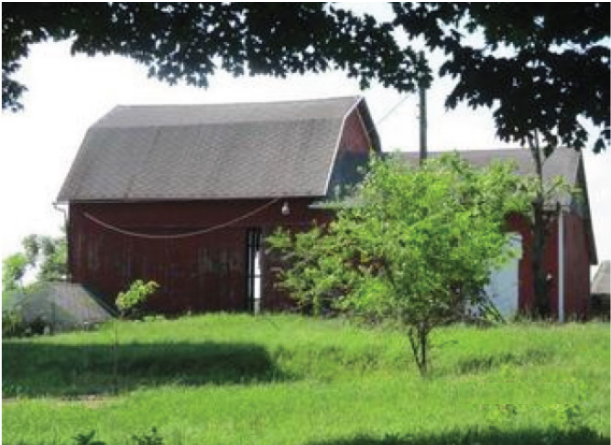
<div>Non-Residential Use - Agricultural - Barn</div> <div>

Site Features and Impact to Value/Marketability			
Feature	Detail	Impact	Comment
Non-Residential Property Use	Agricultural	Neutral	Board fencing around entire property to the barn.
Hazard Zone	No Hazard Zone Noted		
Property Restriction	Land Use	Neutral	Quarter acre lot cannot be built on nor can it be separated and sold.
Site Characteristic	Topography Flat	Neutral

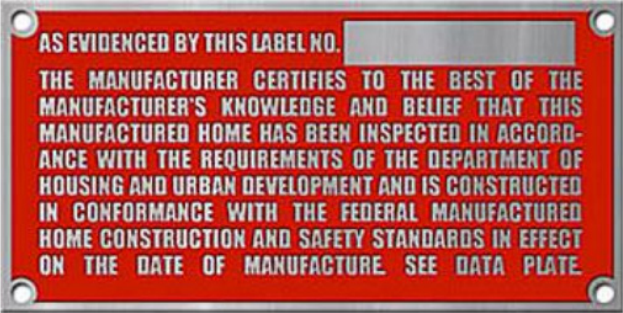
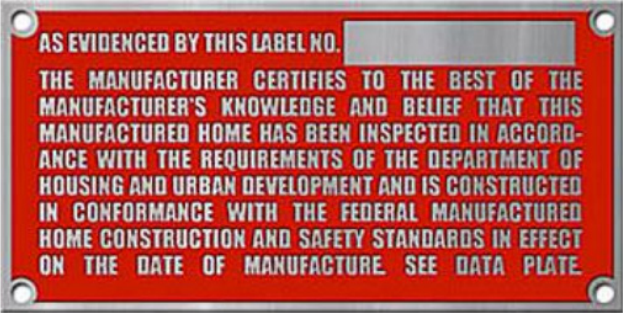
HUD Certification Label			
Label Present for All Sections		Yes	
HUD Certification Number		ore369497	
		ore369498	
Invoice Information			
Purchased from Retailer		Yes	
Retailer Name		Good Deal Manufactured Homes	
Retailer's Invoice Reviewed		Yes	
Manufacturer's Invoice Reviewed		Yes	
Invoice(s) Appear Reasonable		Yes

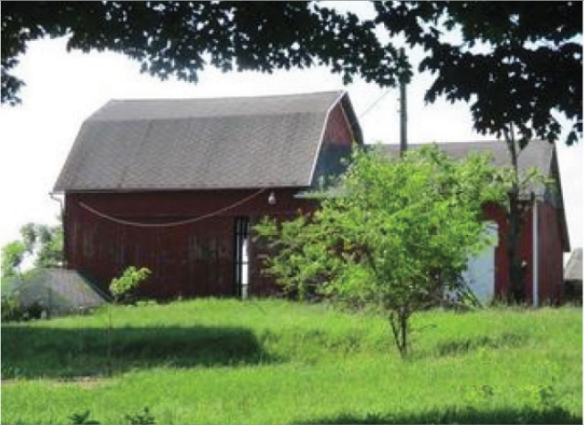
Outbuilding - Barn

Considered Real Property	Yes
Units in Structure	0
Gross Building Area	800 Sq. Ft.

This structure is an existing older barn.

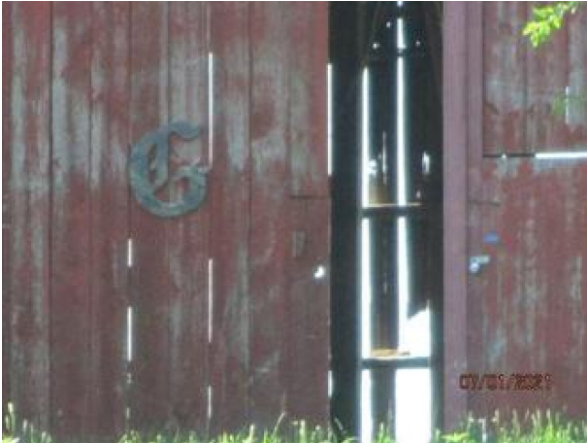
Apparent Defects, Damages, Deficiencies - Exterior Walls and Trim

Apparent Defects, Damages, Deficiencies (Barn)				
The items listed below represent the As Is condition as of the effective date of this report				
Feature	Location	Description	Affects Soundness or Structural Integrity	Recommended Action
Exterior Walls and Trim	Entire Exterior	The overall structure is showing deterioration; major issues include holes in the wall of the building.	No	None

Feature	Location	Description	Affects Soundness or Structural Integrity	Recommended Action
Outbuilding - Barn				
Exterior Walls and Trim	Entire Exterior	The overall structure is showing deterioration; major issues include holes in the wall of the building.	No	None
