Uniform Property Data Report (UPDR)

Example: Single-Family Detached Property (SF1)

SINGLE FAMILY
1023 MAIN ST, ANYWHERE, AB 99999
[https://URL](#)

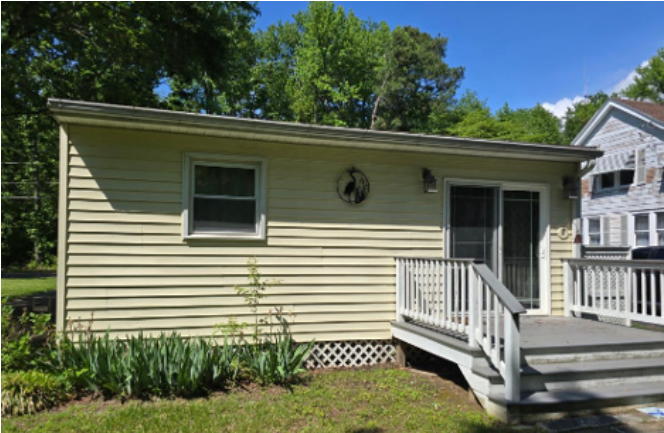
Non-Residential Use - Airbnb

Description Part of the property used as an Airbnb

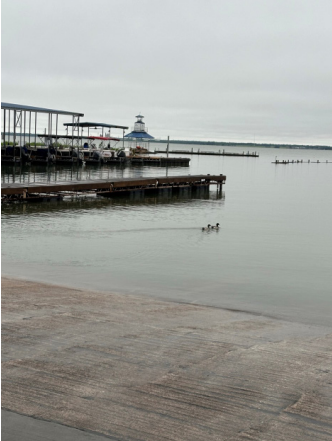
Site Influence - Lakefront

Site Influence		
Influence	Detail	Comment
Location	Lakefront, no beach	Property is located on Lake Happiness

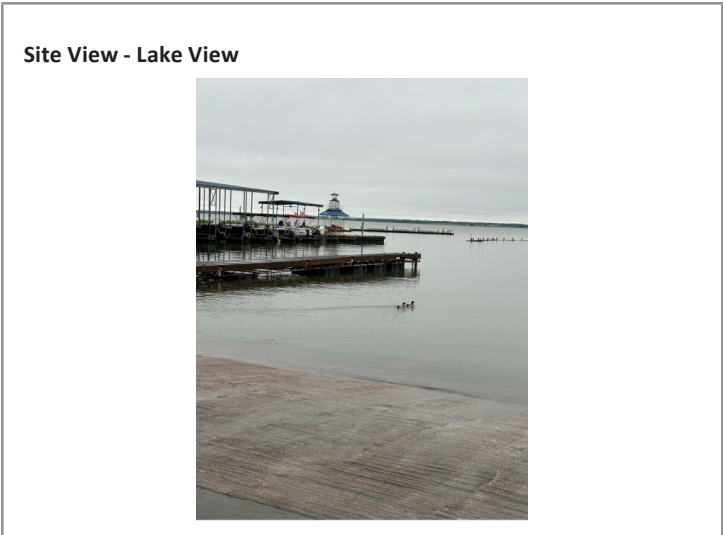
Site View

View	Range	Comment
Lake	Full	View of Lake Happiness

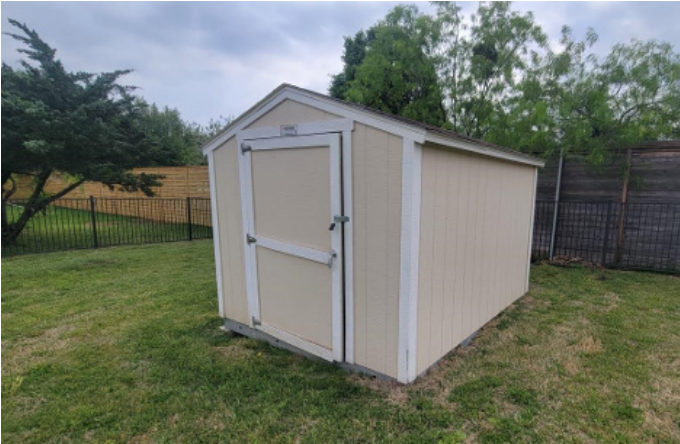
Site Improvements - Toolshed

Property Improvement(s)	Comment
Toolshed	Small Toolshed
Inground Pool	Tiled Pool
Inground Hot Tub	Tiled Hot Tub

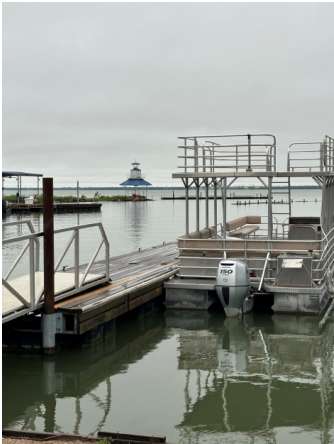
Site Improvements - Dock

Dock
Boat Ramp

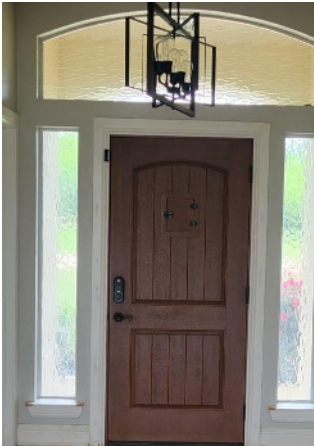
Exterior Updates - Front Door

Updates (Exterior)		
Update	Time Frame	Description
Doors Fully Updated	1 to 10 Years	Exterior door replaced in 2021

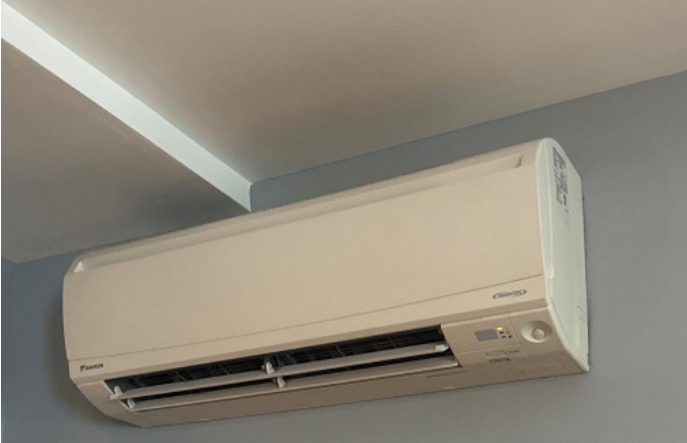
Unit Interior - Ductless Heatpump

Updates (Mechanical Systems)		
Update	Time Frame	Description
Cooling Fully Updated	1 to 5 Years	Ductless heatpumps were added for A/C throughout home

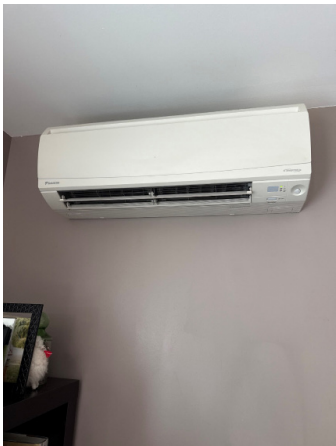
Unit Interior - Other Building - Ductless Heatpump

Updates (Mechanical)		
Update	Time Frame	Description
Cooling fully updated	1 to 5 Years	Ductless heatpumps were added for A/C throughout home
